# Glass Restoration Gives New Life to Stained Windows

*The following article has been reprinted from the June 2015 issue of High Rise Facilities Magazine.*

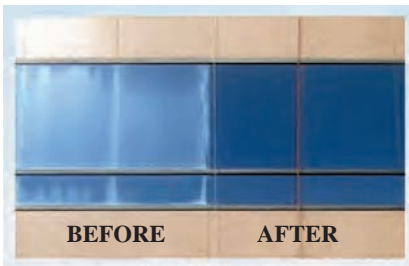
*Glass Restoration in Progress*

Once the cause of mineral deposit staining has been addressed, what is commonly known in the industry as glass restoration can take place. There are two ways to effectively remove mineral deposit stains from glass; they are either chemically rubbed out with a non-acidic rubbing compound or burned off using a harsh acidic cleaner. Both methods are time consuming, expensive and aggressive in nature.

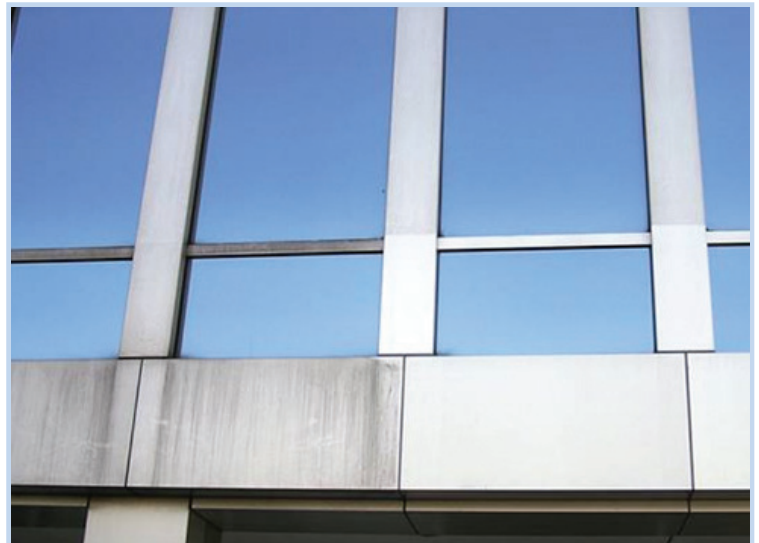
*Preventive maintenance cleanings and deep cleaning of exterior metal can prevent the need for costly painting or replacement.*
